Radiation Physics Note 69

Summary of the Accelerator Division Test Reports on Various Aspects of Uranium

Tony Leveling
March 23, 1988

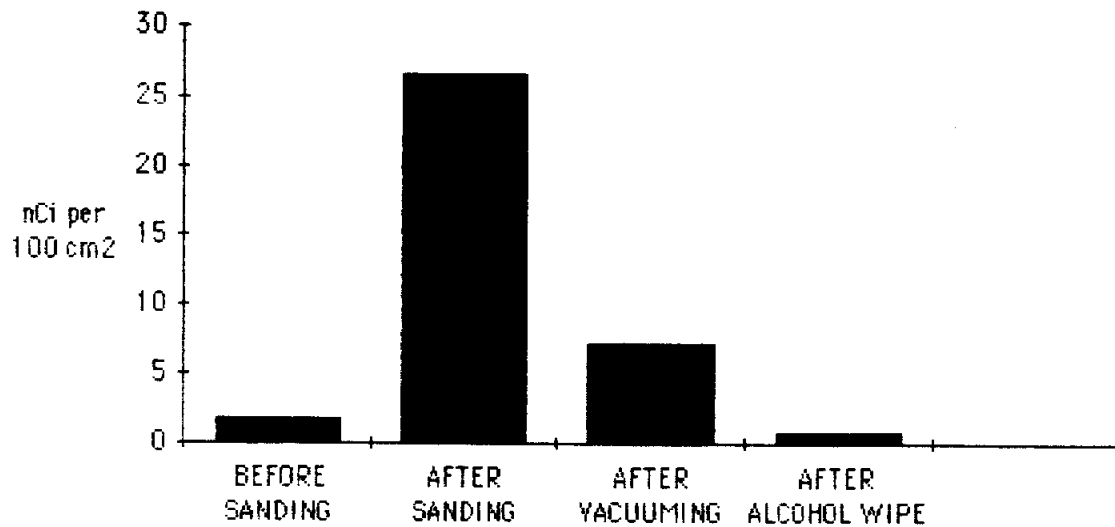
2. The vacuum step reduced contamination levels by about 73% averaged over the two surfaces. It is felt that the levels remaining after the vacuum step are too high to be left because the levels are too high to easily control and present a significant surface contamination problem. (See Graph 1 below.)
3. The contamination levels were further reduced with alcohol and Kimwipes by a factor of 88% averaged over the two surfaces. These levels are comparable to those experience with the MFH plates and are manageable given the controls in place at IB4.

AVERAGE CONTAMINATION LEVELS DURING TEST PHASES

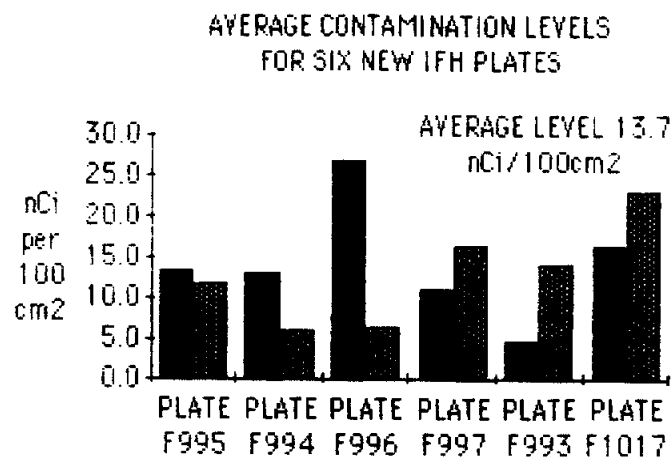
The chart below shows the results of the contamination level survey taken Thursday, January 15 on the new IFH plates. The dark bar indicates the average of six smears taken on a side and the light bar indicates the same average for the reverse side (total of 72 smears).

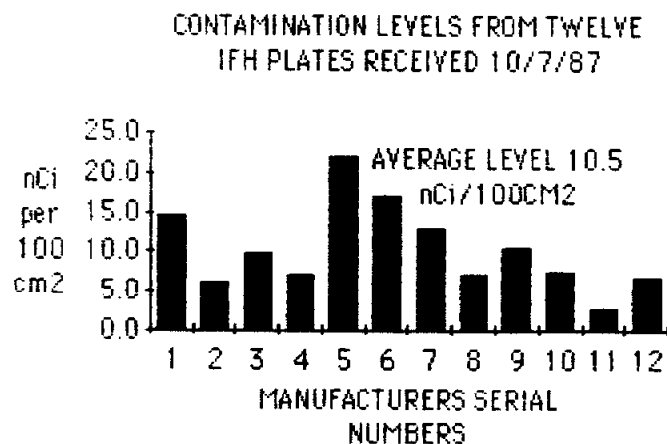
The graph below shows the contamination levels found in the first shipment of IFH plates received in October, 1987. Only one smear was taken per plate.

It appears that the contamination levels found in the second shipment may be a little higher (30%) compared to the first shipment.

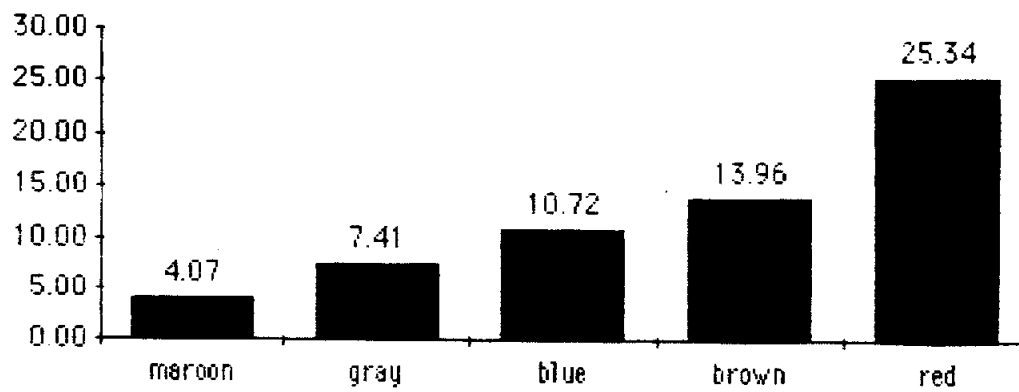
AVERAGE PLATE CONTAMINATION LEVELS AFTER SANDING

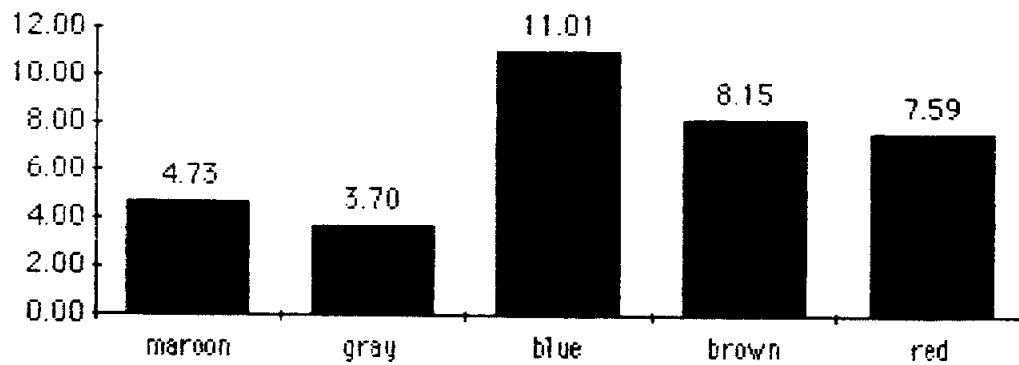
AVERAGE PLATE CONTAMINATION LEVELS AFTER VACUUMING

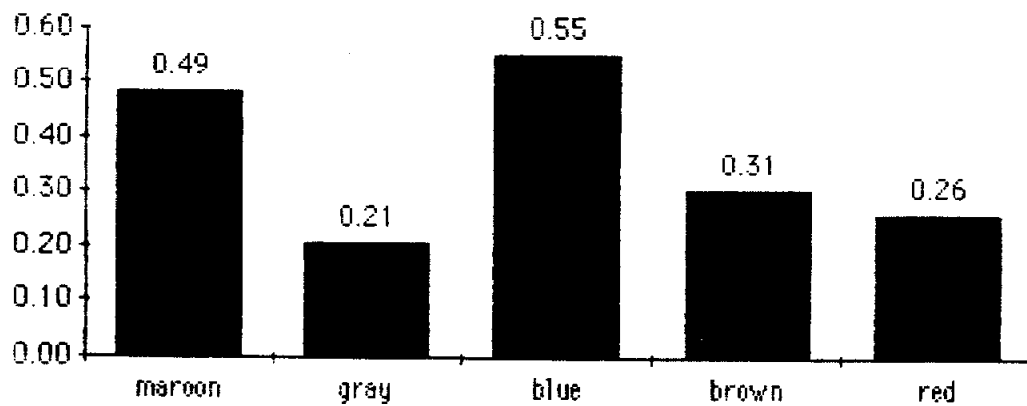
AVERAGE PLATE CONTAMINATION LEVELS AFTER ALCOHOL WIPE

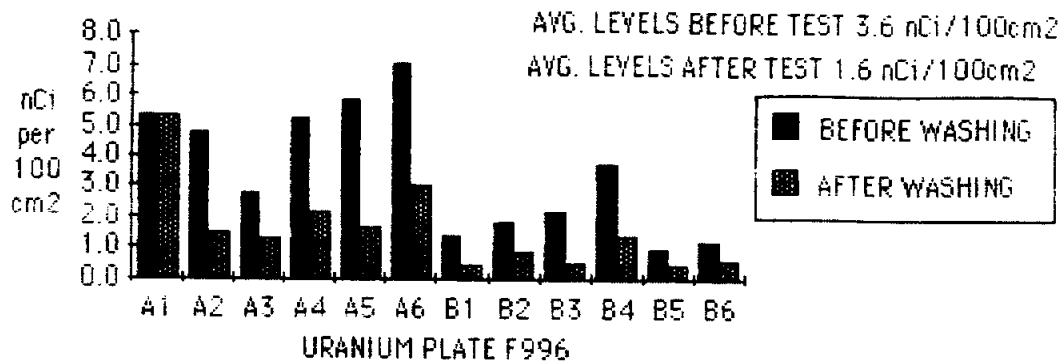
The test was performed on a single IFH plate. The plate was divided into twelve areas (six per side) and each of the areas were smeared before and after the spray test. The graph below shows the effectiveness of the plate cleaning with the sprayer.

CAR WASH STYLE
URANIUM PLATE CLEANING TEST
JANUARY 21, 1988

1. The results of the initial smears are lower than those obtained during the plate arrival survey on January 14. The reason is that the smear/glove that used is not as effective as the glove/smear combination used during the initial survey. For the future, a standard smear/glove combination will be used to ensure that consistent results are obtained.

2. We have no explanation for the before and after contamination levels found for Plate Area A1.
3. Contamination were reduced by 56% over the original levels even when the Plate A1 area is considered. If Plate A1 area is excluded, the levels drop by a factor of 64%.
4. This method of cleaning is more desireable because no uranium oxide dust is created as is the case with sanding. Water spills are easier to find and are also easier to clean up.
5. The sprayer did remove lint fibers which were evident on the edges of the plate before spraying. It is not known whether the wires which are believed to cause shorts when high voltage is applied existed or were removed by this test. Remember that the removal of lint and wires is the primary reason for cleaning

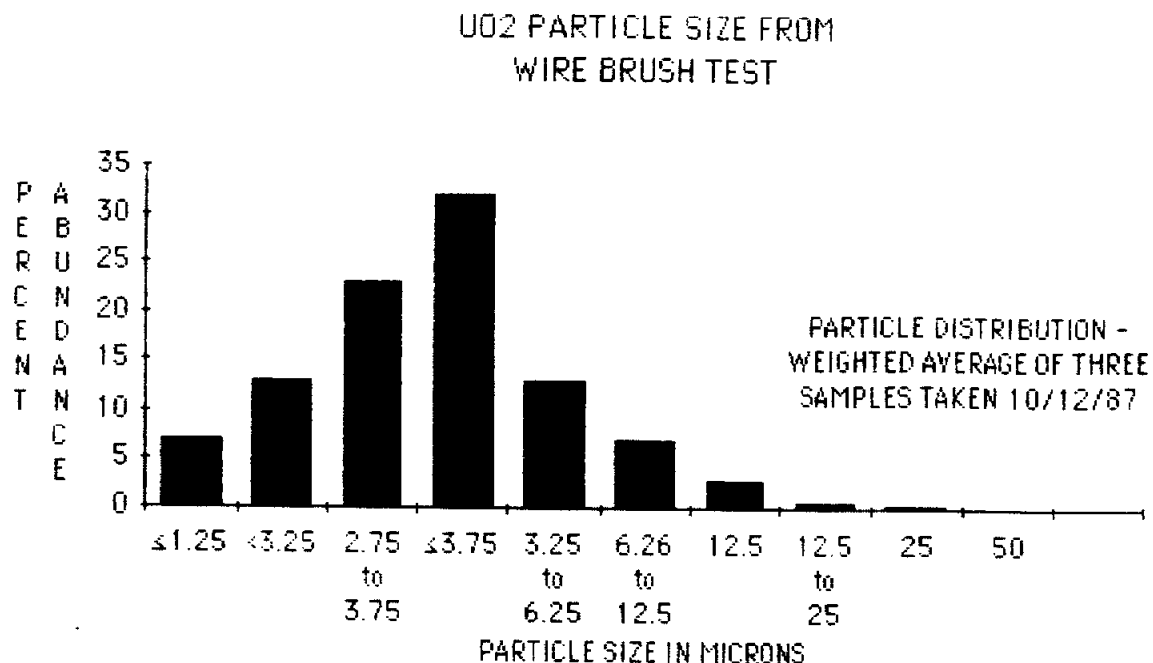
The range of particles apparent from these samples correspond to those found in the microscopic examination of particles which was done in

October 1987. The result of that microscopic examination is reproduced here for information.

This latest test gives us confidence that only trace quantities of UO₂ exist at < 1.0 μ m.

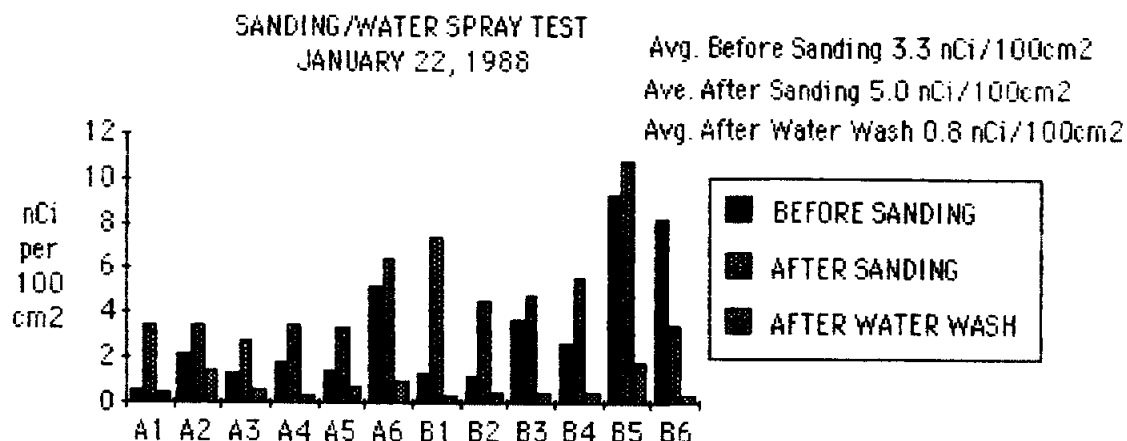
Plate 1017 Contamination Levels - nCi/100 cm²

The graph below shows the before sanding, after sanding and after washing results. The table shows the values obtained on which the graph is based.

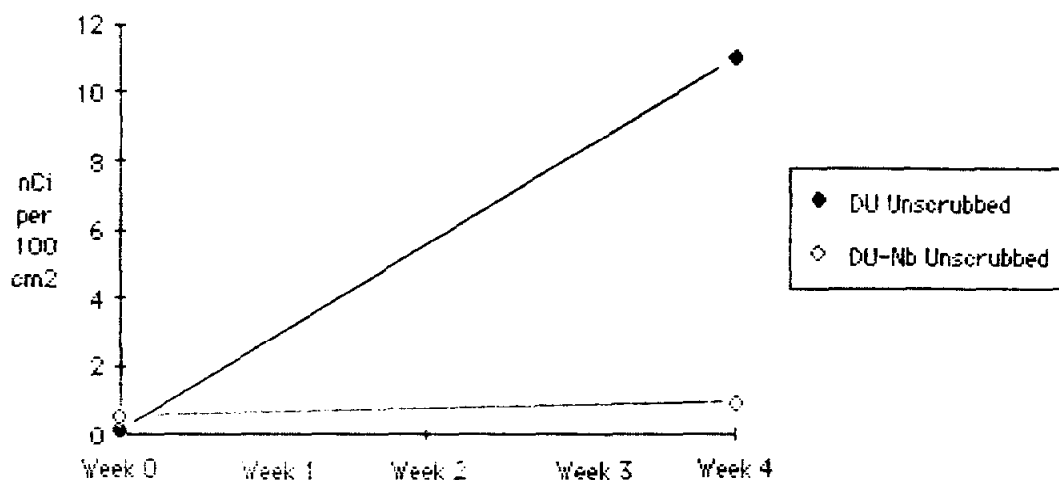
Graph 1

The contamination growth is plotted below as a function of time for the unscrubbed coupons and scrubbed coupons in graphs 1 and 2 respectively. All contamination data collected during is tabulated in Attachment

Unscrubbed Coupon Contamination Growth
January 20, 1988 through February 18, 1988

1. The unscrubbed DU coupon contamination levels increased by a factor of about 100 over the period of the test. The increase in contamination levels is attributed to the formation of the olive green oxide since the smear was only green. In general, this coupon presented the greatest contamination hazard for these test conditions.

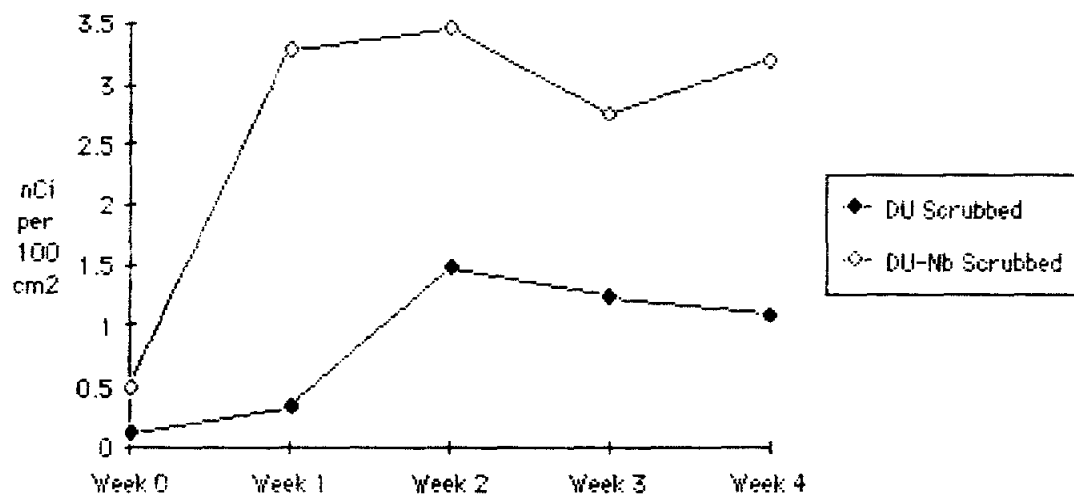
Scrubbed Coupon Contamination Growth
January 20, 1988 through February 18, 1988

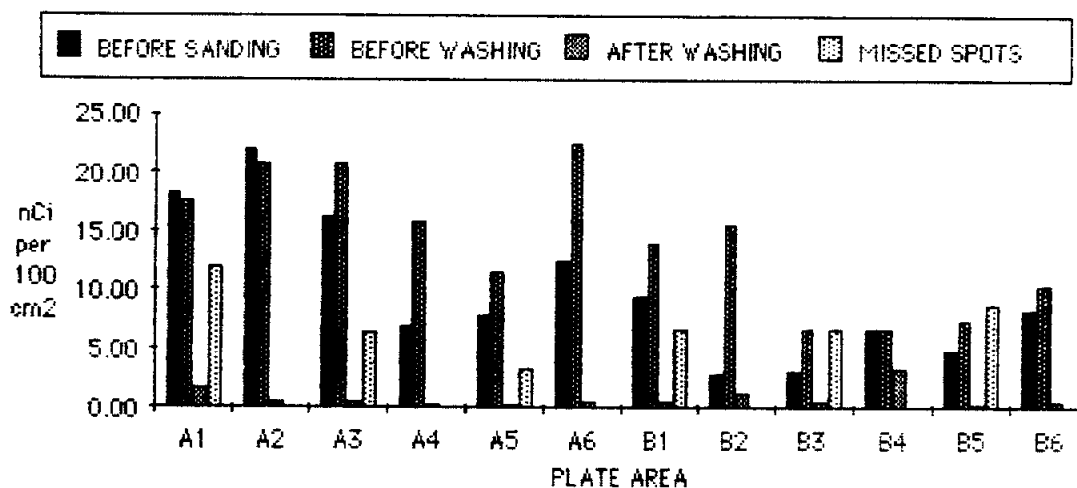
Graph II

DRY SANDING/SPRAY TEST
MARCH 27, 1988

Loose contamination levels were reduced by about 94% if the three astericked areas are not considered and by about 90% if they are considered.

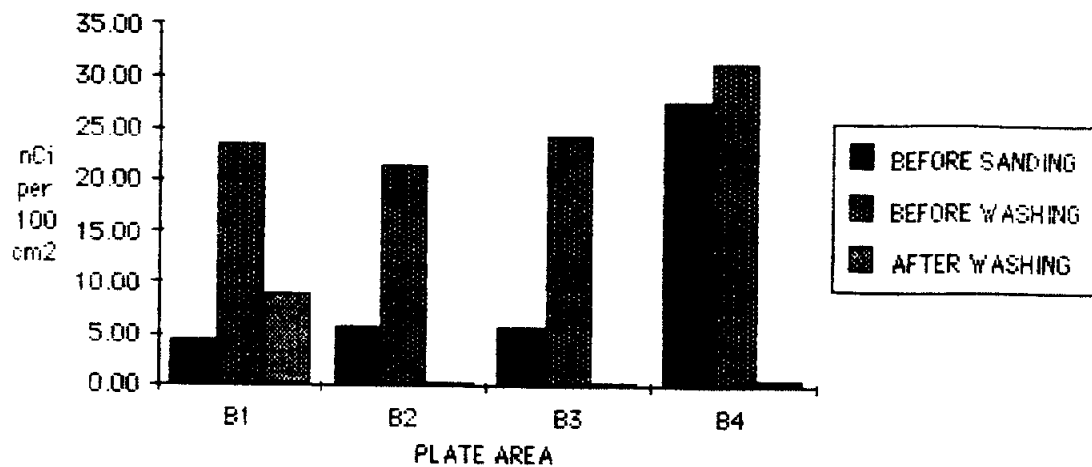
Graph III

WET SANDING/SPRAY TEST
1/28/88

The contamination levels noted before washing (after sanding) in the wet test are consistently high and also some of the highest seen to date. This is attributed to two factors.

The 500 psi sprayer reduced loose contamination levels by about 56%. The 2200 psi sprayer reduced levels by 71%. Both of these results were obtained before it was discovered and verified that areas of the plates could be missed. It appears that the higher pressure sprayer is more effective at contamination removal.

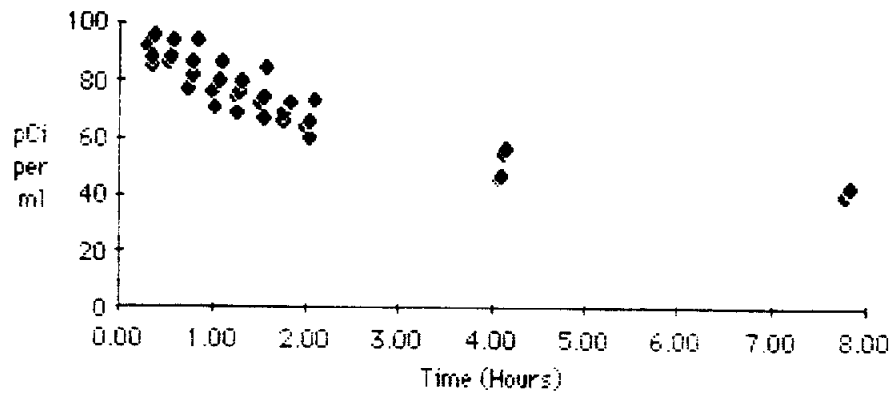
Graph I

Uranium Oxide Settling Test
Data After First Eight Hours
3/8/88

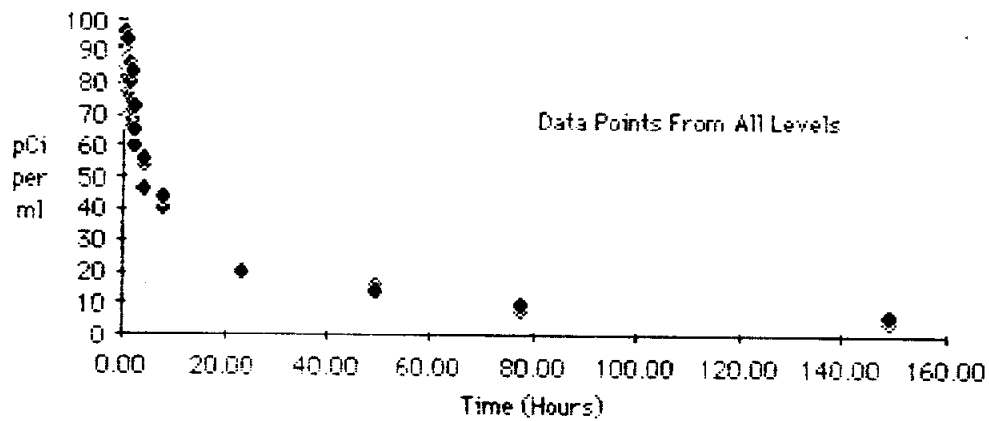
Graph II

Uranium Oxide Settling Test
3/8/88 to 3/14/88

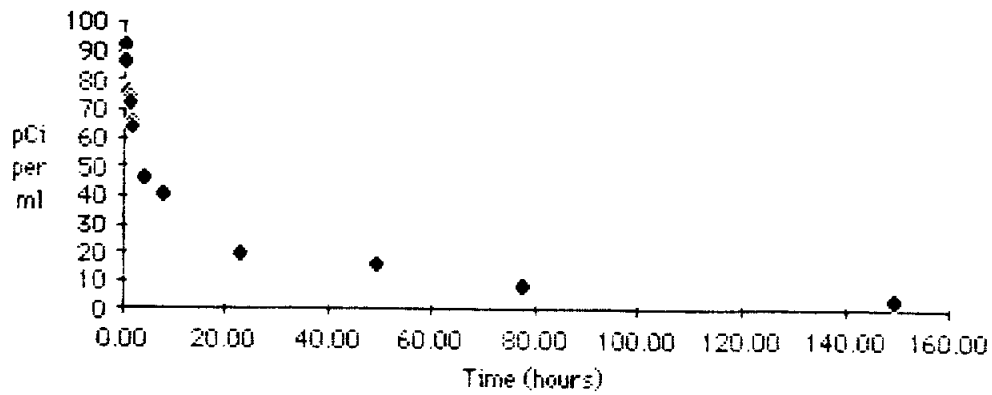
Graph III

Uranium Oxide Settling Test
3/8/88 to 3/14/88
6" Level Data

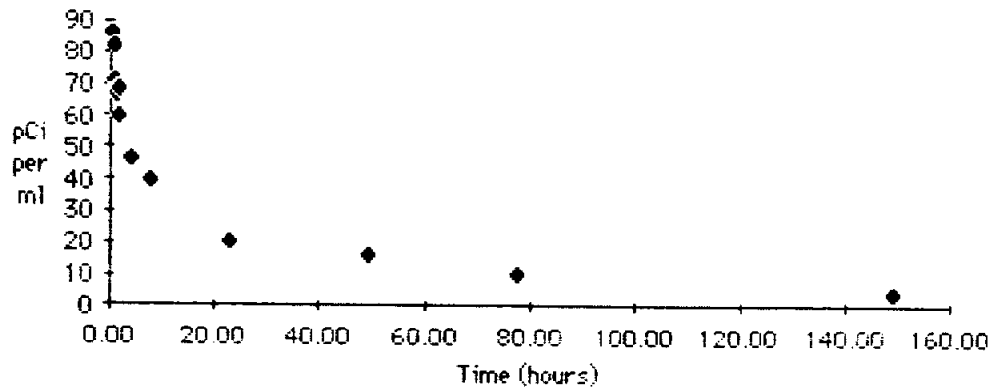
Graph IV

Uranium Oxide Settling Test
3/8/88 to 3/14/88
12" Data

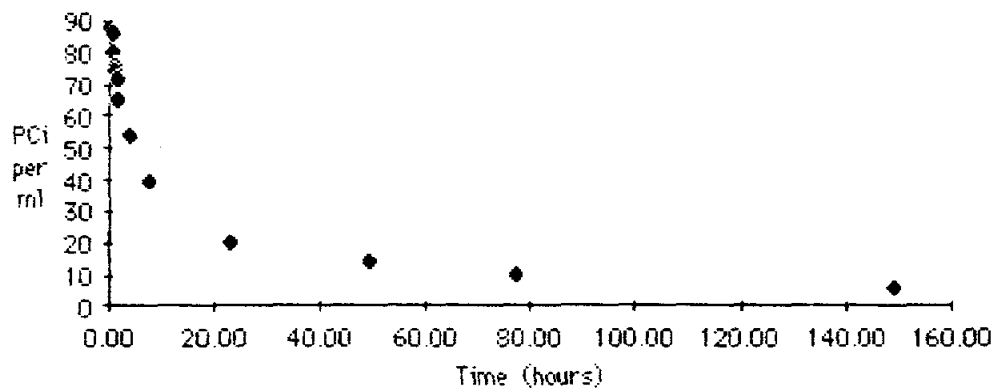
Graph V

Uranium Oxide Settling Test
3/8/88 to 3/14/88
18" Level Data

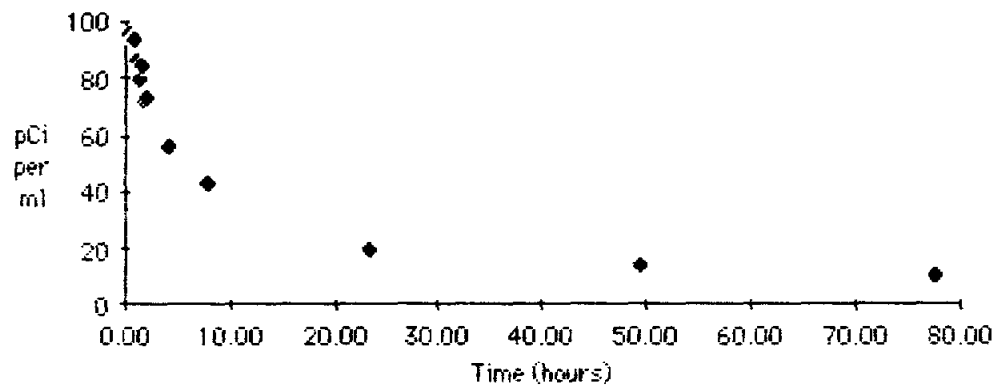
Graph VI

Uranium Oxide Settling Test
3/8/88 to 3/14/88
24" Level Data

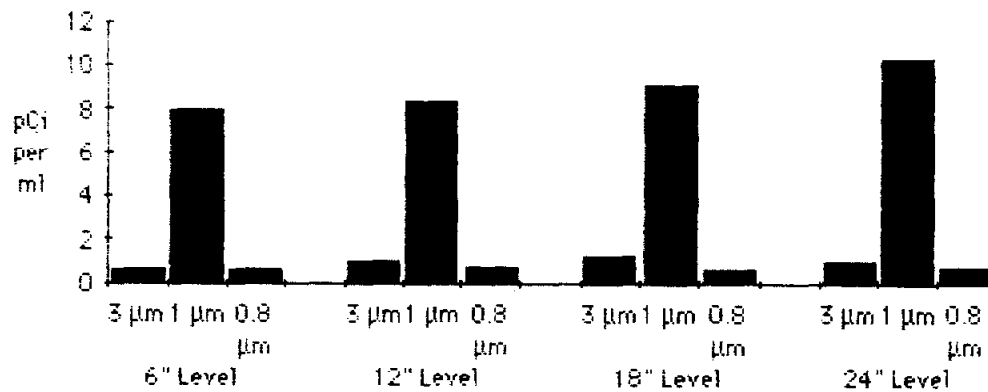
Graph VII

Uranium Oxide Settling Test
Particle Size Determination After 24 Hours
at 6", 12", 18", and 24" Levels
3/9/88

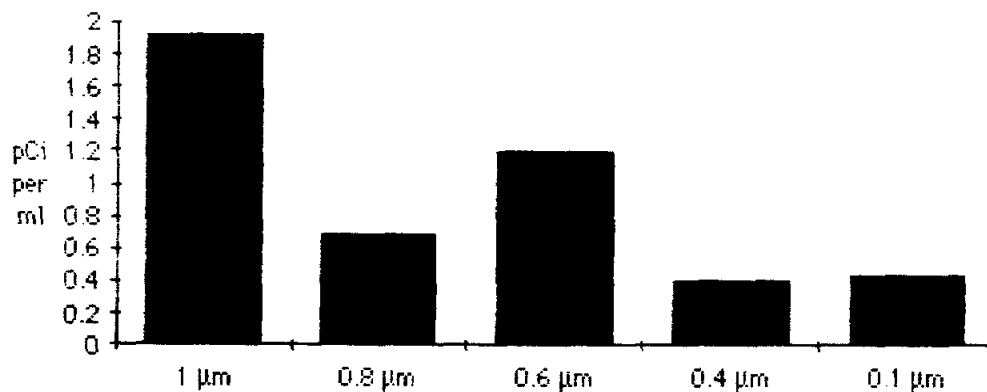
Graph VIII

Uranium Settling Test
Particle Size Analysis at 9" Level
at Conclusion of the test 3/14/88

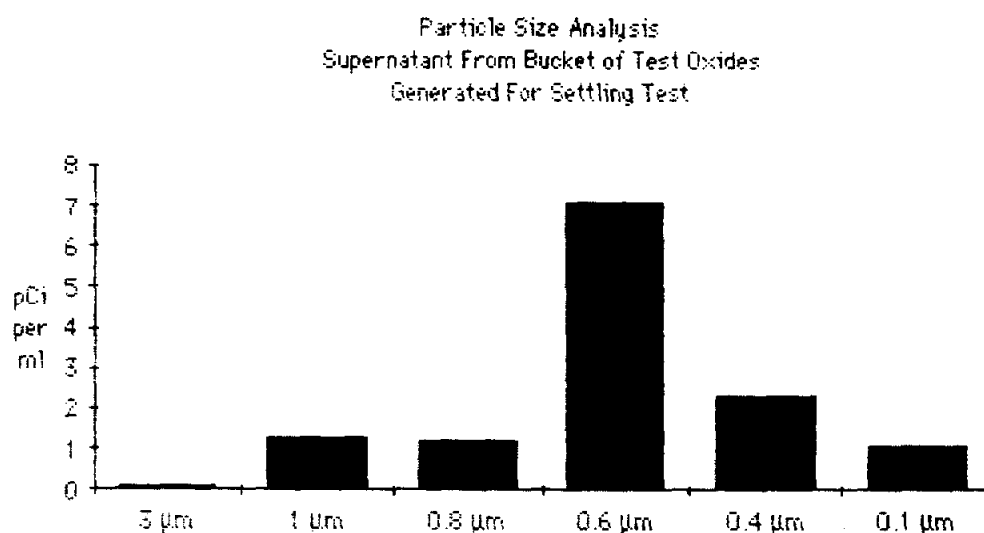
Graph IX shows the concentrations of particle sizes of the material not used in the column test but generated by wet scrubbing the plate. The sample of these particles came from the two to three gallons of supernatant. A rough

guess, assuming that these particles were concentrated in the initial 325 ml pour and did not ever settle during the test, would be that these oxides would be present at about 75% of the concentrations shown in Graph IX. This is an incremental increase above the concentrations present but not identified in the filter paper analysis discussed above.

It was assumed that the 3.0 μm and larger particles had settled out; these were not analysed.

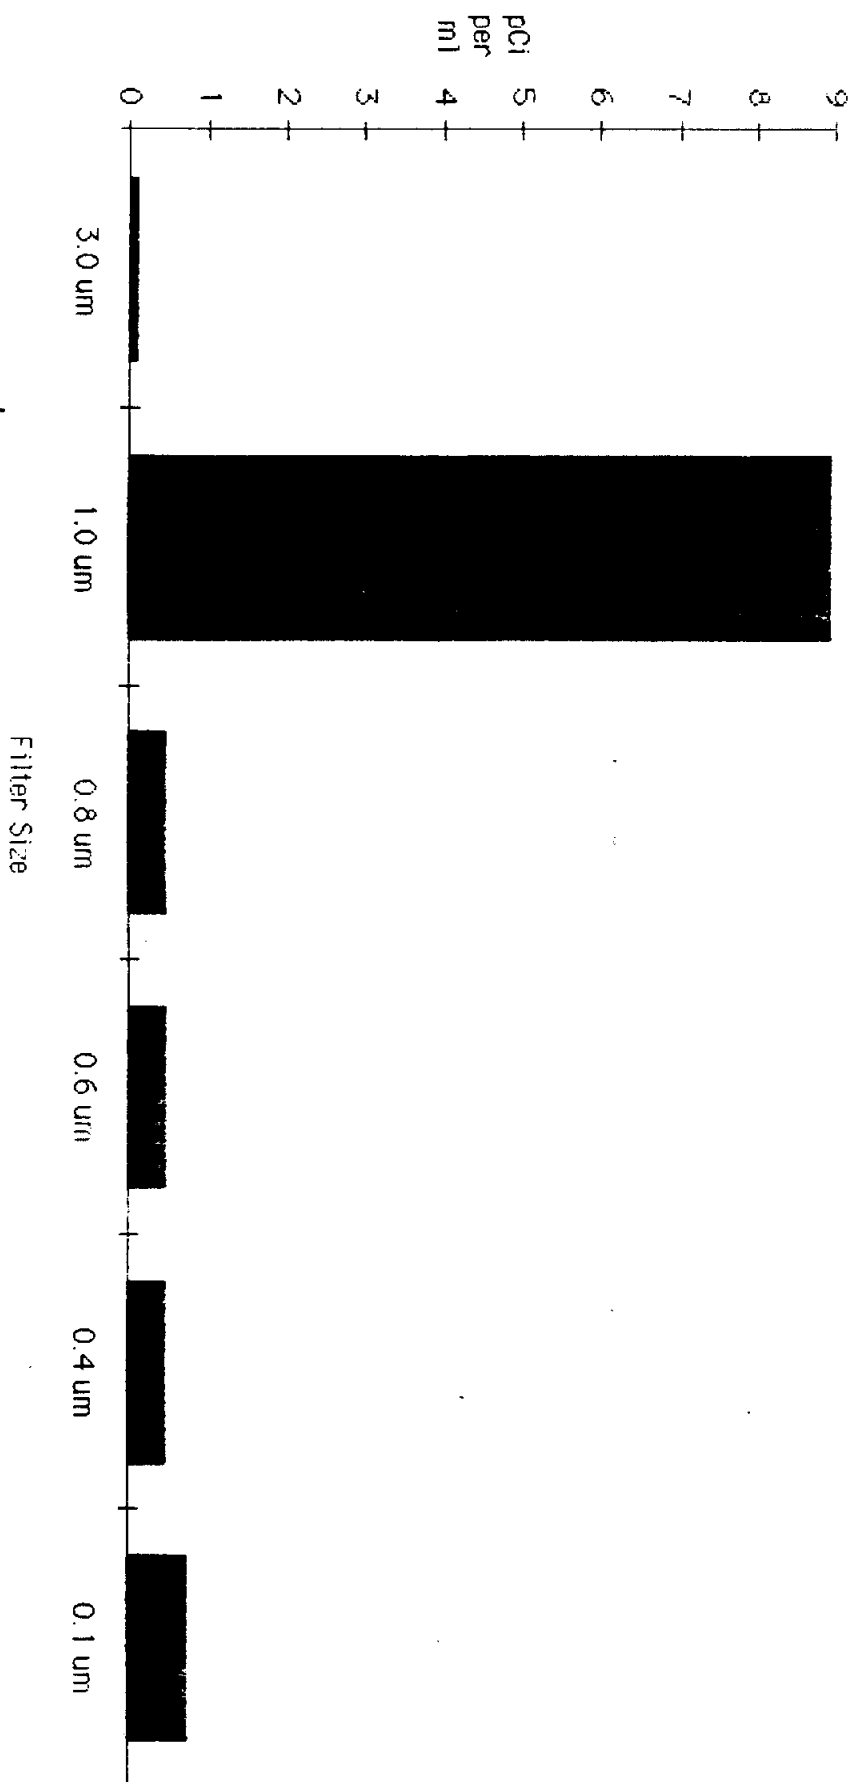
Second Settling Test
Particle Size Analysis at Conclusion of Test
3/22/88
